Annual Report NPDES Municipal Separate Storm Sewer System Permit

PUBLISHED BY THE MONTGOMERY COUNTY DEPARTMENT OF ENVIRONMENTAL PROTECTION
FOR THE MARYLAND DEPARTMENT OF THE ENVIRONMENT

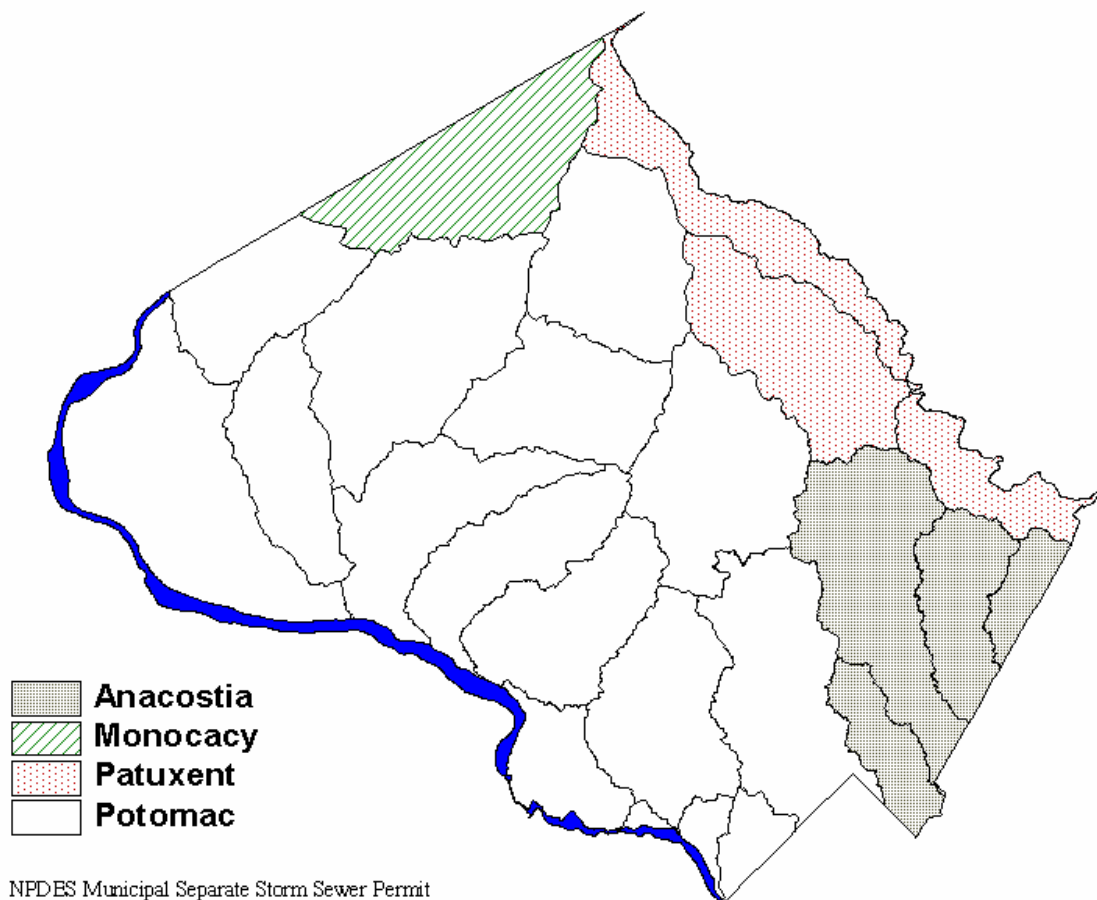
Figure III-2. Montgomery County Major Watersheds.

The stormwater implementation information must be reported by major County watershed. Figure III-2 shows the four major County watersheds for the purposes of permit reporting. From smallest to largest by drainage area size, these are the Monocacy, the Anacostia, the Patuxent, and the Potomac. The Monocacy, the Anacostia, and the Potomac major watersheds are all contained within the State's Middle Potomac Tributary Team Basin.

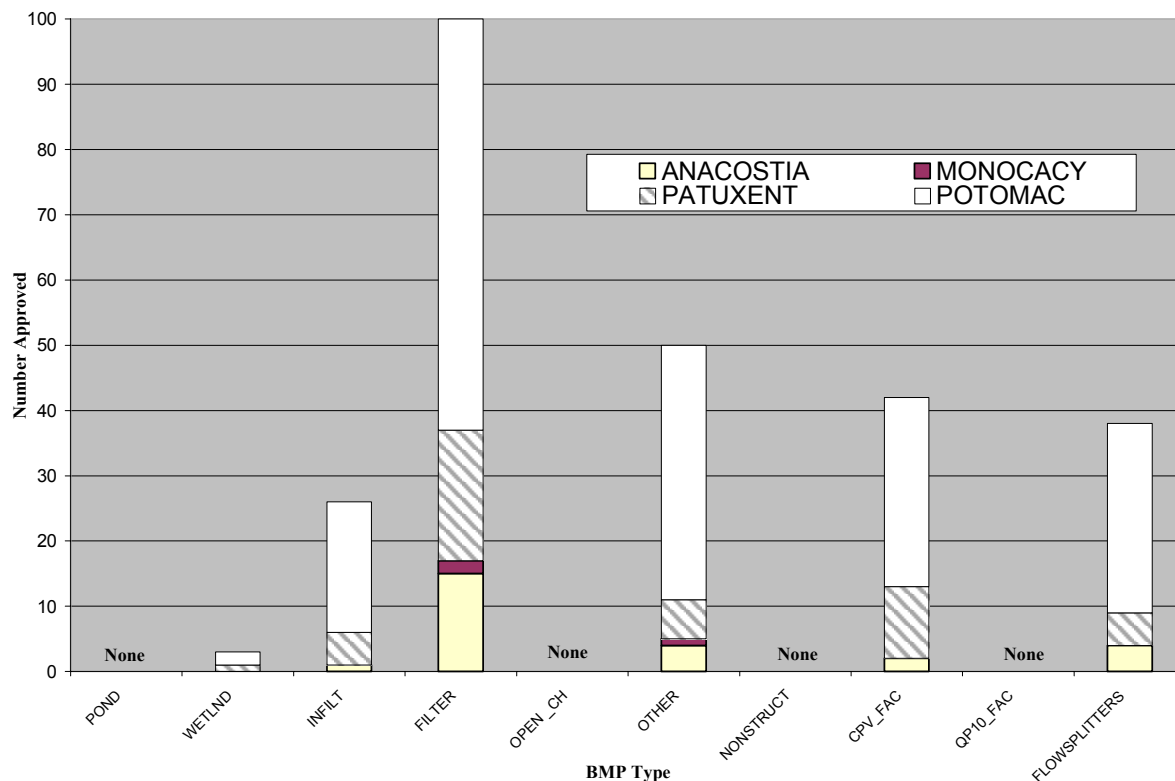
FIGURE III-3. Best Management Practice (BMP) Implementation Information by County Major Watershed

Figure III-3 compares types of BMPs approved and implemented during 2001 by County major watershed. This information is also included in the database on the CD in Attachment A. Among all watersheds, the category with the largest number approved was that of "FILTER", stormwater filters. Stormwater filters are water quality practices that capture, temporarily store, and pass the volume to be treated for water quality through a filter bed of sand, organic matter, soil, or other media. Design variants include surface, underground, and perimeter sand filters, organic filters, pocket sand filters, and bioretention systems. These are individual structures, and do not reflect treatment train relationships, i.e. where initial runoff treatment is through a sand filter which then discharges into a pond for additional treatment.

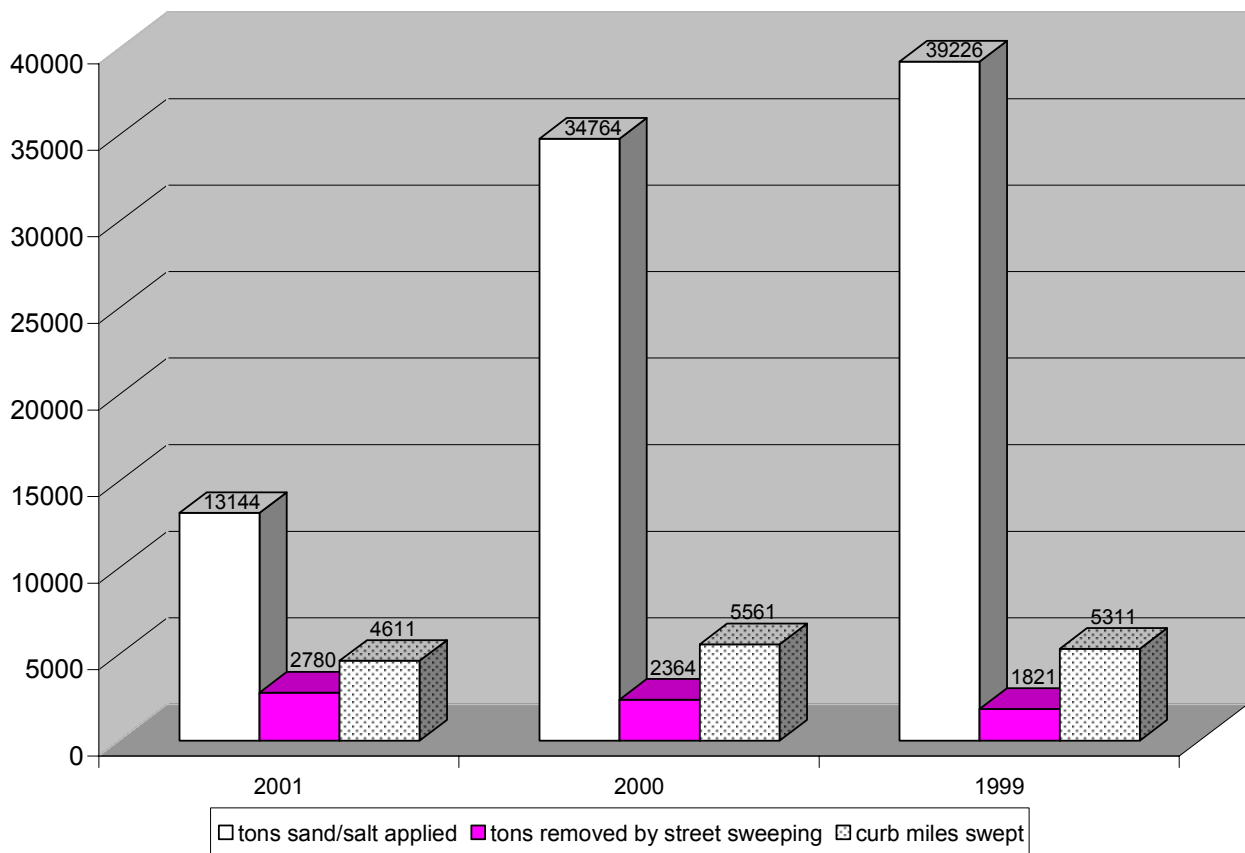
FIGURE III-5. Material Applied for De-icing Activities and Removed through Streetsweeping from 1999 through 2001.

As shown in Figure III-5, the County's street sweeping program removed a fairly consistent amount from 1999 to 2001 (from 1,821 to 2,780 tons of materials), although the tons of sand and salt applied varied greatly (from 39,226 tons in 1999 to only 13,144 tons in 2001.) The much lower amount applied in 2001 reflects an exceedingly mild winter and lack of major or numerous snow or ice events. The number of curb miles is greater than the estimated 2,176 miles of County roads because arterial roads and those in the Piney Branch Central Business District are swept more than once during the year.

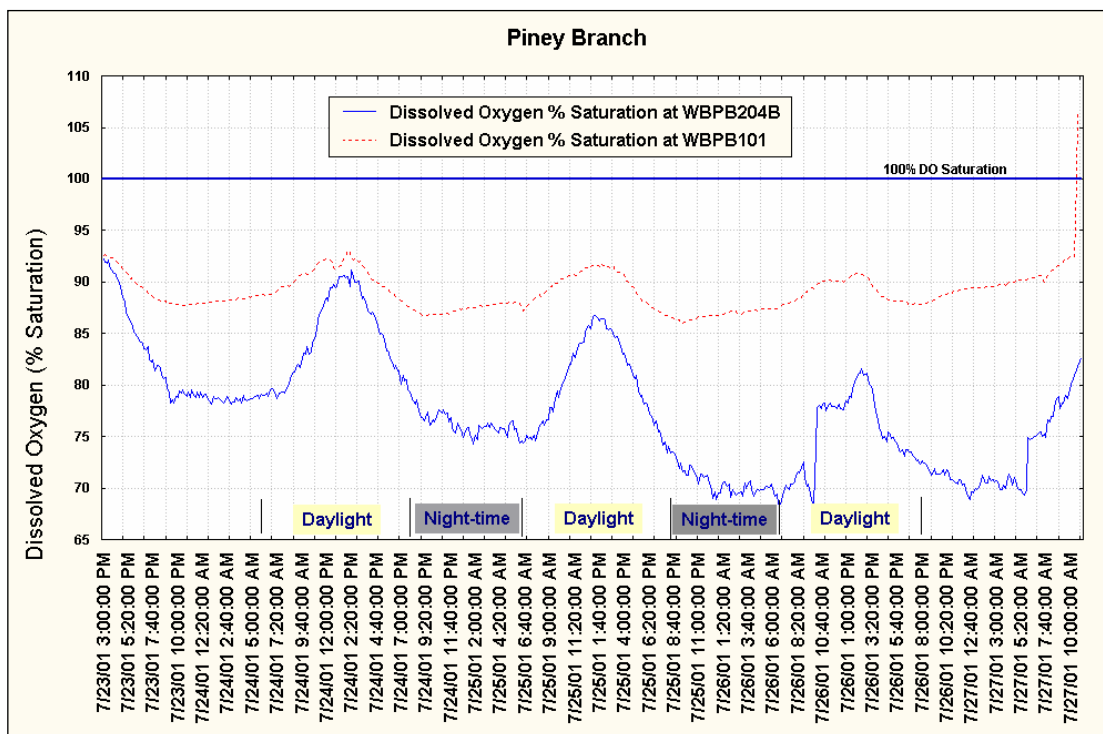
FIGURE III-9. Comparison of Dissolved Oxygen Conditions.

In the Piney Branch SPA, monitoring seems to already be showing development-related impacts on stream resource conditions. Figure III-9 compares summer dissolved oxygen conditions for two subwatersheds within Piney Branch. The blue line is data collected from a mainstem station (WBPB204B) downstream of significant recent land use changes, newer developments which implemented enhanced site design and stormwater management controls. The red line shows data collected from the Western Tributary station (WBPB101) in a subwatershed with older, mainly residential development.

There is a significant daily pattern of peaks and valleys at the mainstem station not seen in the Western Tributary. This pattern seems to reflect a well-documented phenomenon in aquatic systems, the night-time depletion of oxygen by plant and animal respiration without accompanying plant photosynthesis (and oxygen production) that occurs during sunlight hours. The magnitude of the difference day to night is driven by the amount of plant biomass relative to the animal biomass.

Additional field evaluations indicated that significantly greater amounts of periphyton (substrate-associated plants) and fine sediments were present in the mainstem than in the Western Tributary. This pointed to eutrophication--nutrient enrichment for periphyton growth in the mainstem not evident in the Western Tributary. The County has begun baseflow, grab sample nutrient monitoring at a network of stations throughout the Piney Branch SPA to identify any specific areas, and their land uses, that are contributing to this eutrophication problem in the mainstem. Possible nutrient pathways include:
